SERVICE INFORMATION LETTER MD-80/90 SERIES

**PASSENGER ADDRESS SERVICE INTERPHONE CALL SYSTEM (PASICS),
ELECTRONIC SWITCHING UNIT (ESU) P/N 686-3000-003, used on board the
MD-80/90 series aircraft**

Distorted or choppy PA audio when using the cockpit aft pedestal handset.

**SIL98-2
Nov. 18, 1998
Page 1**

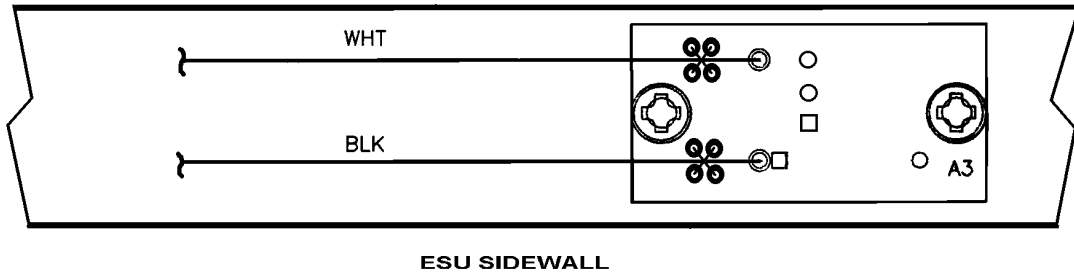
A3 Trim Board Location

**Possible miswire (reversal) of two wires attached to the Trim Board (A3) in ESU P/N
686-3000-003 serial numbers 0902 thru 0954.**

If operator has test fixture to verify operation of unit, test per SB686-3000-23-3 Rev.1, page 7, test step *L. Audio Test – Pilot PA Audio*, subtest (6). If distortion is evident at A3R1 maximum setting, remove unit cover and inspect position of white and black wires attached to A3 Trim board mounted on side wall of ESU. The white wire should be attached to the A3 board eyelet towards the top and the black in an eyelet towards the bottom, as shown below. If reversed, remove A3 board from sidewall and correct position of the wires, then retest unit.
