SERVICE BULLETIN

REVISION 1 To Service Bulletin SB-1300/2022A-032A

RDR-1300/IN-2022A WEATHER RADAR SYSTEM

TO INCREASE PAWL TRAVEL TO PREVENT CRUSHING OF SPRING

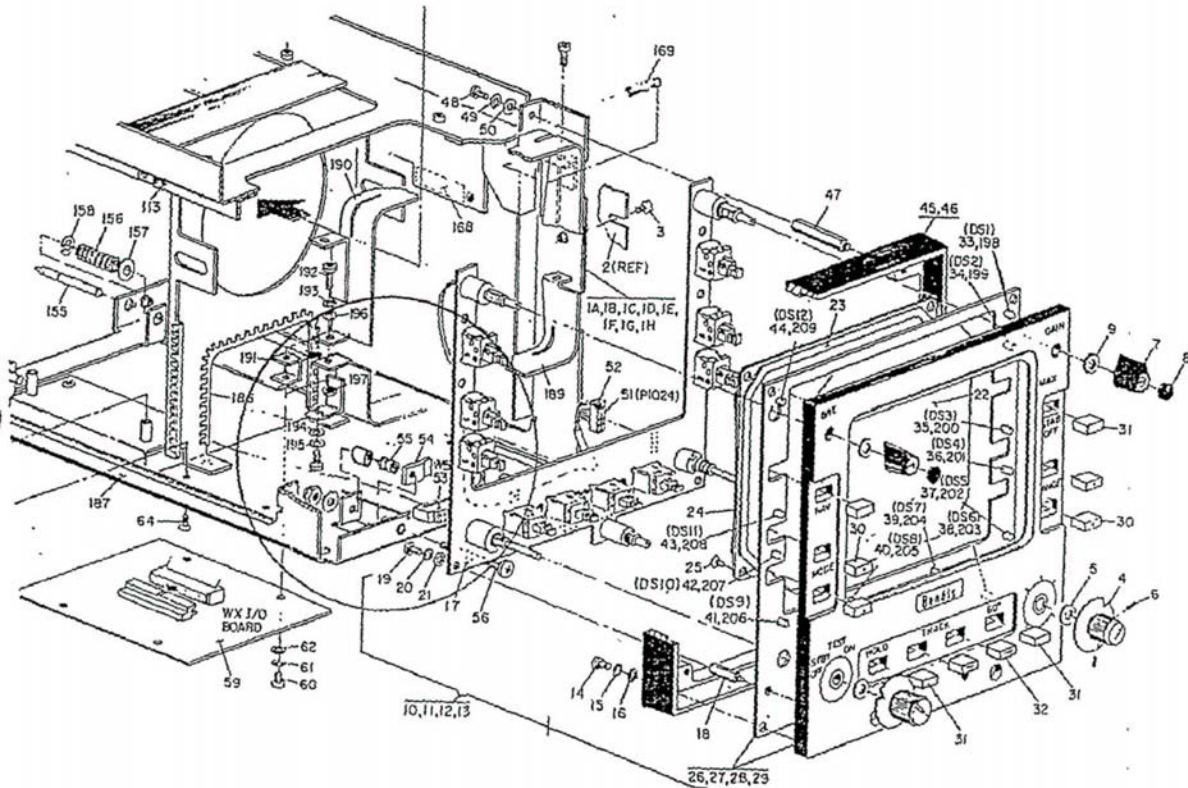
Figure 1. Locking Pawl Location

This modification prevents crushing the spring on the locking pawl assembly by increasing the travel of the pawl.

- (1) Remove the dust cover (2) and front panel assembly (10).
- (2) Refer to Figure 1 of this Service Bulletin for location of locking pawl (54) and associated parts.
- (3) Remove and discard two springs, two hex nuts, two washers, two spacers, two screws, and two locking pawls.
- (4) Install two locking pawls (P/N 4005134-0001), two springs (P/N 35007-0053), two special screws (P/N 08950000-0001), two tubular spacers (P/N 34021-0005), two Teflon washers (P/N 36005-0120), and two hex nuts (P/N 45067-0005) onto the two locking pawl assemblies as shown in Figure 2 of this Service Bulletin.
