## SERVICE BULLETIN

### REVISION 1 to SERVICE BULLETIN SB-T-03-RDR-1FB-001

#### NC-105B NAV Concentrator

**Subassembly Mod 4 to Master Processor Module  
P/N 3606423-0501**

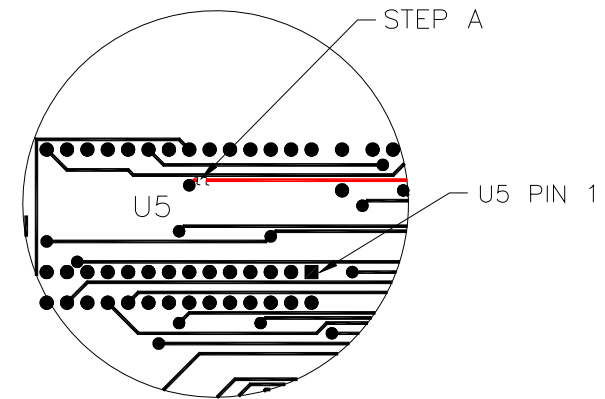
FIGURE 1  
VIEWED FROM SOLDER SIDE

| CUT TABLE I | | |
|---|---|---|
| VIA UNDER U5 | U5-22 | U2-5 TO U5-22 |
| U11-9 | VIA | U11-9 TO TP19 |

ON THE SOLDER SIDE OF THE BOARD, IMPLEMENT THE CUT LISTED IN THE CUT TABLE (TABLE I) AS SHOWN IN FIGURE 1. COVER ALL CUTS WITH FIND NO 6. USE THE LISTED CONTINUITY POINTS AS VERIFICATION THAT CONTINUITY HAS BEEN BROKEN.
