SERVICE BULLETIN

Service Bulletin SB-T-04-1400C-0001

RDR-1400C WEATHER RADAR SYSTEM

**IN-2025B Radar Indicator
P/N 4001670-2511 thru -2520
Unit Mod 11**

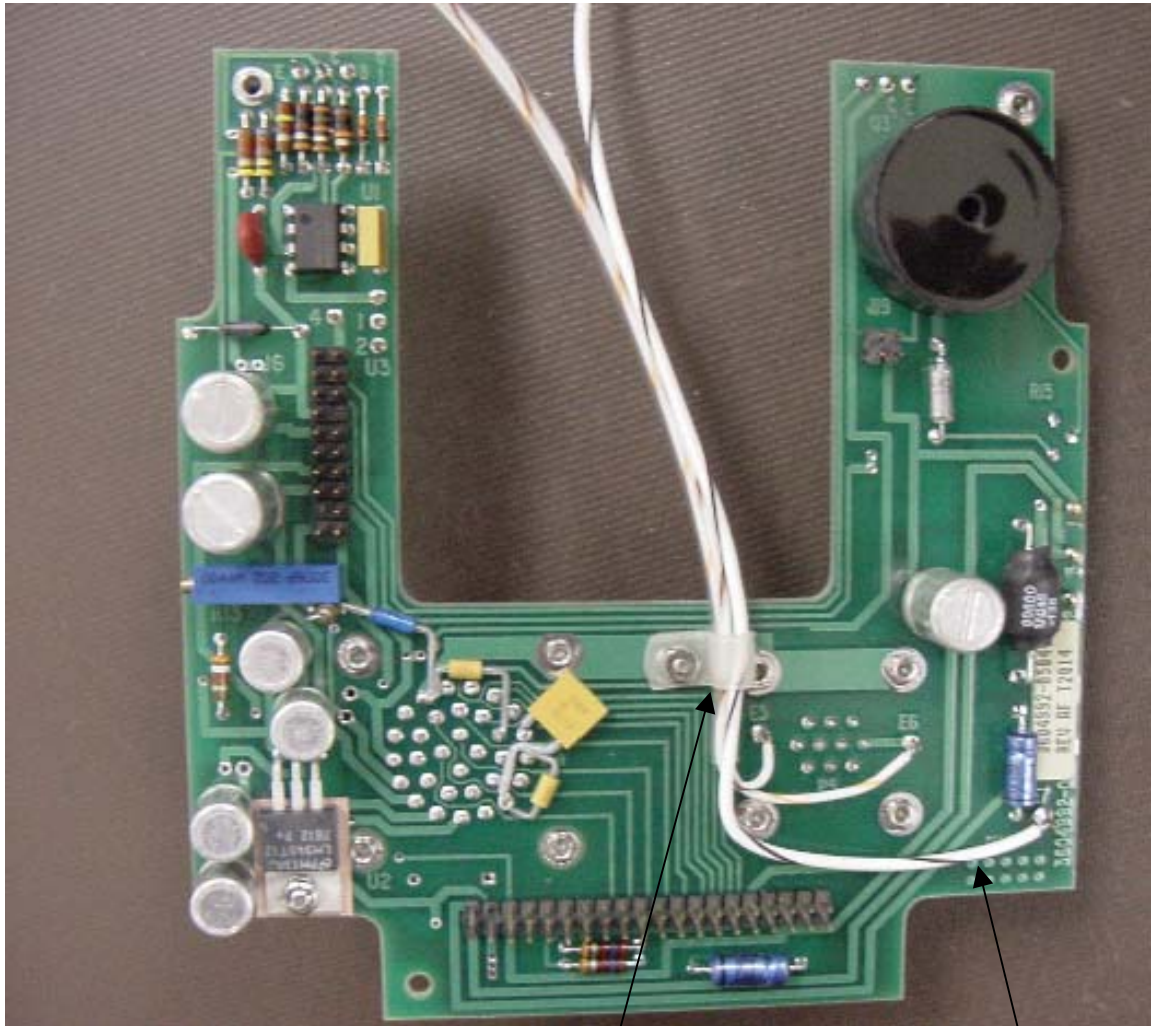
Figure 1. Rear Panel CCA

2. Remove and Replace Clamp

1. Remove Wht/Blk Wire

- 1) Disassemble the IN-2025B according to the referenced maintenance manual procedures, to remove the Rear Panel Assembly.
- 2) Remove the Rear Connector CCA p/n 3604992-0504.
- 3) Refer to Figure 1. Remove White/Black wire from Rear Connector CCA and attach Solder lug p/n 32002-002D to the wire.
- 4) Remove clamp from Rear Connector CCA. Remove only the White/Black wire from clamp.
- 5) Replace clamp with new clamp p/n 33033-0003 that holds the other two wires.
- 6) Remove and replace existing Rear Connector CCA rev label with new label.
- 7) Refer to Figures 2 and 3. Attach White/Black wire to HVPS screw using existing screw.
