## SERVICE BULLETIN

### REVISION 1 to Service Bulletin SB-T-04-1400C-0001

#### RDR-1400C WEATHER RADAR SYSTEM

IN-2025B Radar Indicator  
P/N 4001670-2511 thru -2520  
Unit Mod 11

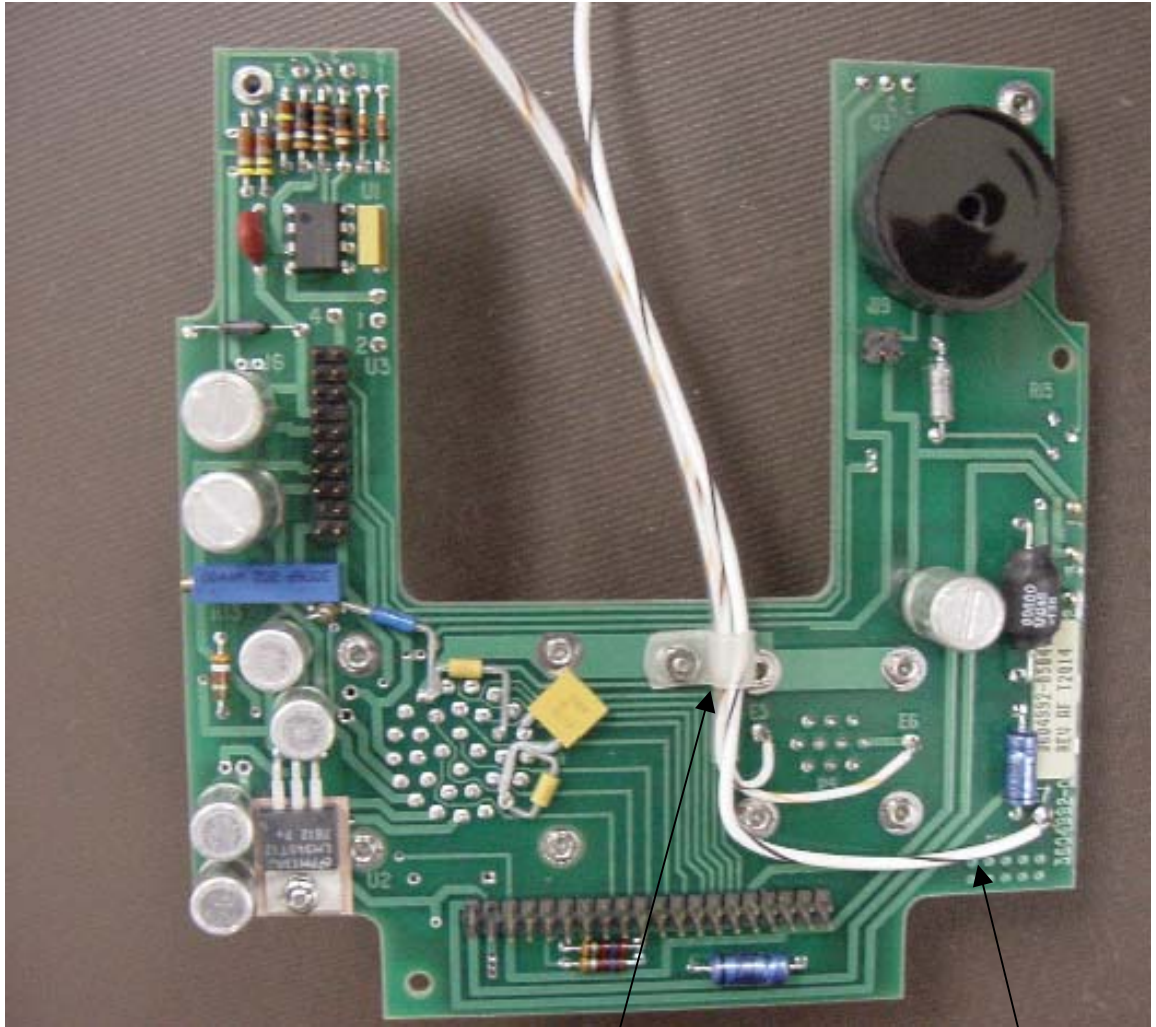
Figure 1. Rear Panel CCA

2. Remove and Replace Clamp

1. Remove Wht/Blk Wire

- 1) Disassemble the IN-2025B according to the referenced maintenance manual procedures, to remove the Rear Panel Assembly.
- 2) Remove the Rear Connector CCA p/n 3604992-0504.
- 3) Refer to Figure 1. Remove White/Black wire from Rear Connector CCA and attach Solder lug p/n 32002-002D to the wire.
- 4) Remove clamp from Rear Connector CCA. Remove only the White/Black wire from clamp.
- 5) Replace clamp with new clamp p/n 33033-0003 that holds the other two wires.
- 6) Remove and replace existing Rear Connector CCA rev label with new label.
- 7) Refer to Figures 2 and 3. Attach White/Black wire to HVPS screw using existing screw.
