SERVICE BULLETIN

Service Bulletin SB-T-04-1500B-0002

RDR-1500B WEATHER RADAR SYSTEM

PRODUCT IMPROVEMENT TO ENHANCE HIGH VOLTAGE RELIABILITY

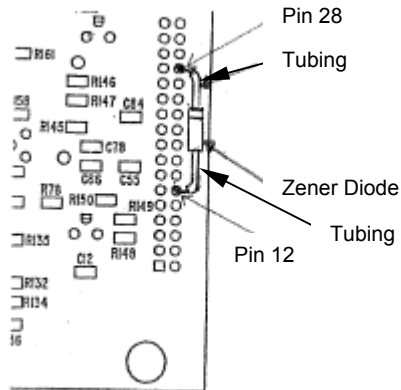
This change provides additional protection from high voltage arcing.

- a) Attach two pieces of teflon tubing to the Zener diode and solder the diode to the board as shown below. Be sure to observe that the polarity band is positioned as shown.
