SERVICE BULLETIN

MD-80/90 & B717 SERIES

PASSENGER ADDRESS SERVICE INTERPHONE CALL SYSTEM (PASICS),
ATTENDANT HANDSET ASSEMBLY P/N 686-1000-002, MODIFICATION TO
PRECLUDE INTERMITTENT RESETTING.

686-1000-23-5

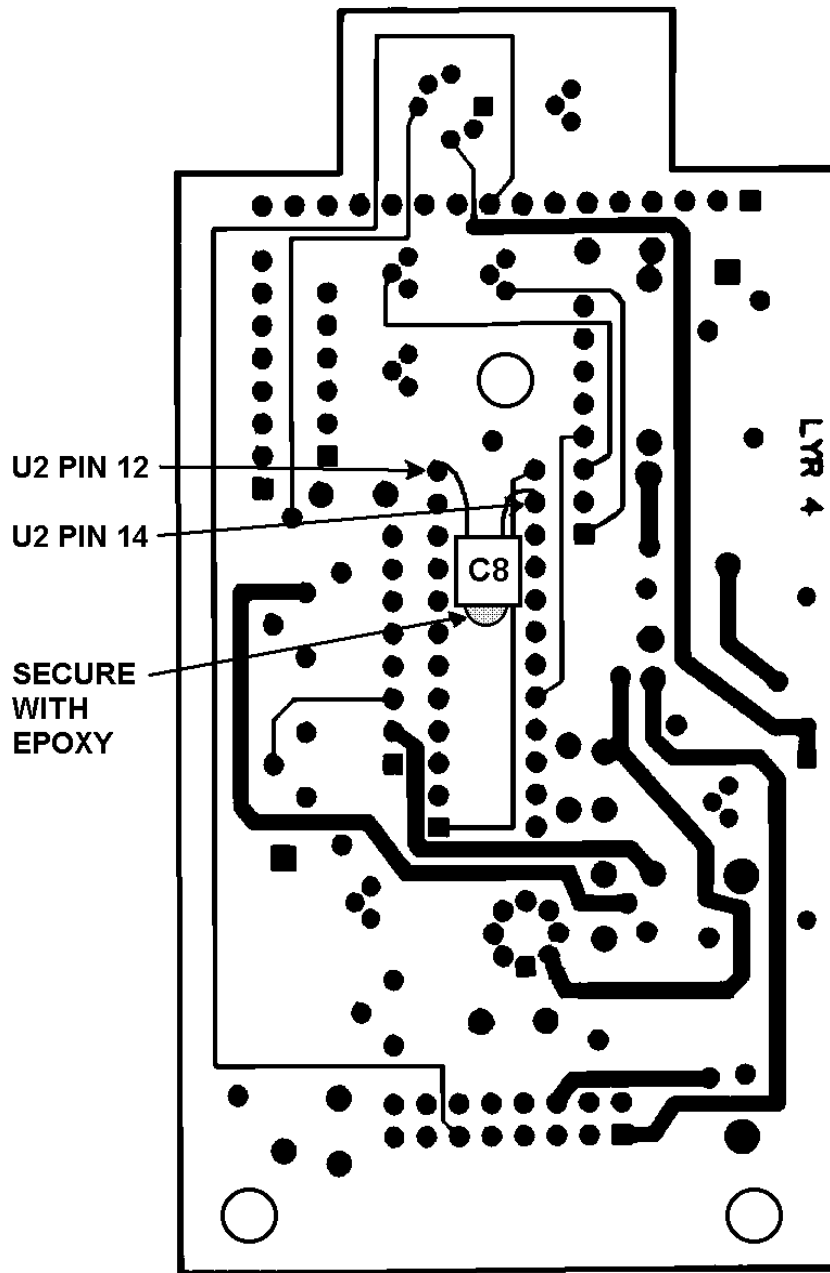
**Figure 1. A2 Circuit Card
Solder Side – Location of C8**

- B. Reason: To correct a possibly misprogrammed Programmable Logic Device (PLD) on the A2 circuit card, which can cause the Call light not to extinguish on an Attendant handset hang-up following the first call after initial power application. Also adding a filtering capacitor to allow the use of newer PLD parts, whose input characteristics have changed from the original design.

- (1) On the A2 card, locate and remove the defective U2 component. Install new replacement component P/N M235A909-1.
- (2) Install new capacitor C8, P/N M39014/01-1219 (100pf, 200V), on solder side of card, to U2 pins 12 & 14, as shown in Figure 1 of this bulletin.
- (3) Using a small quantity of clear fast drying epoxy, secure C8 to card surface, as shown in Figure 1 of this bulletin. Allow epoxy to dry before proceeding.
- (4) Using an acid brush and isopropyl alcohol, clean newly soldered areas. Ensure cleaned area is dry, then apply conformal coating (Humi Seal 1B31) on all reworked areas.

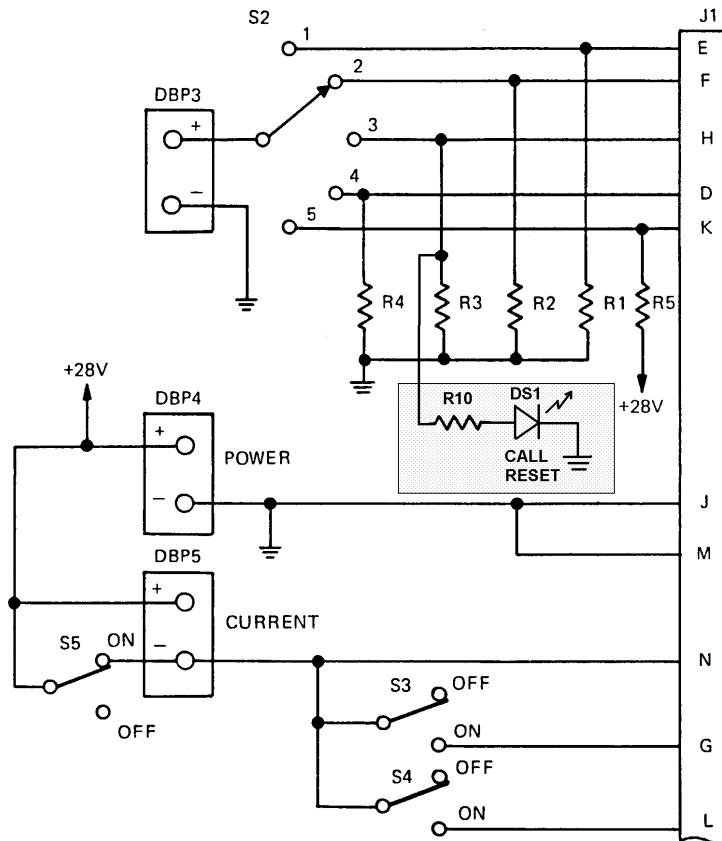
Modification to the tester includes the addition of one LED indicator and one resistor. Depicted below is a partial schematic of the tester, with the added circuitry shown in the shaded area. A parts list for the new items is also provided below.

ADDED PARTS, IN SHADED AREA
