SERVICE LETTER

Equipment Type(s): DA-1503B p/n 071-01593-0100 Antenna Drive

Subject: Field Modification of Units due to Manufacturing Error

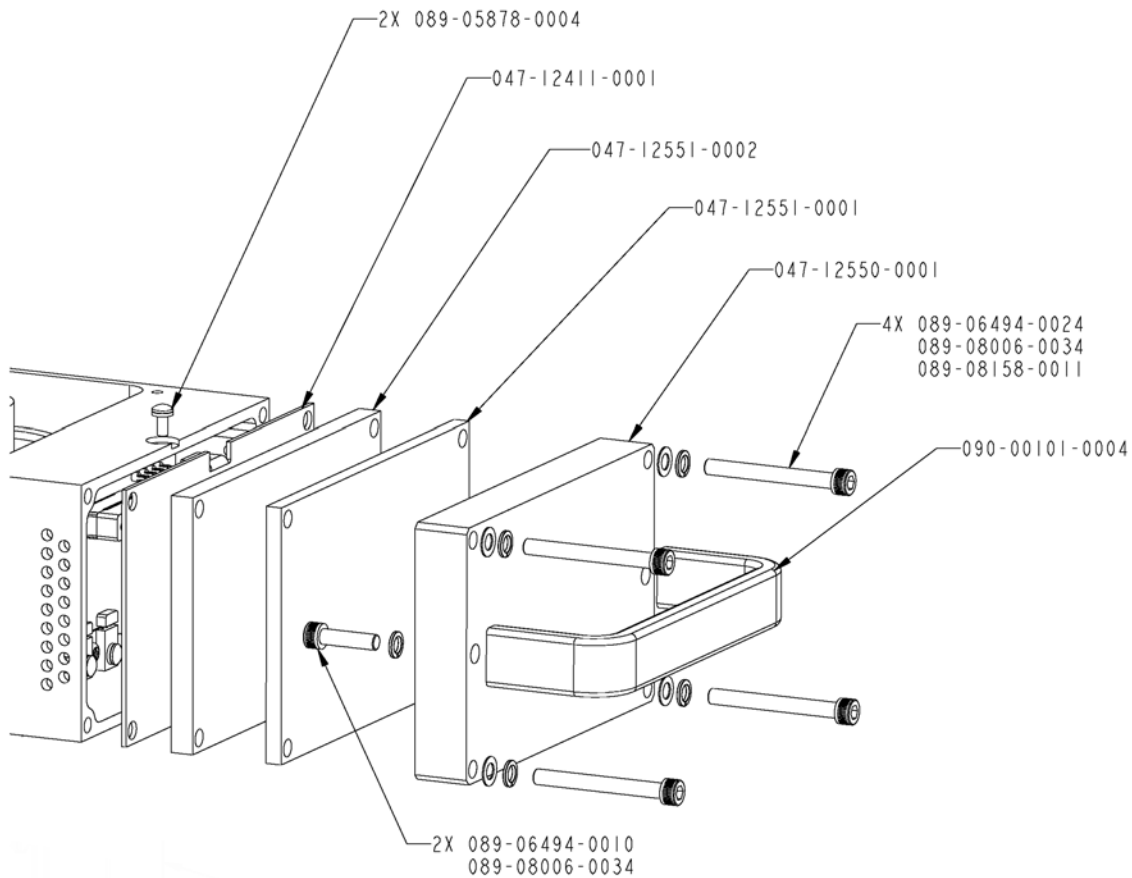
Figure 2. DA-1503B Antenna Drive Counterweight Assembly

Affected Units: The following serial numbered units are believed to have incorrect hardware installed at the factory.

If the screw length is 1.25 inch, all four screws must be replaced with p/n 089-06494-0024 which is 1.50 inches long. See Figure 2 for disassembly and re-assembly guidance.

If the screw length is 1.50 inch, re-attach the original screw as no modification is required.
